**PERDIDO GROUNDWATER CONTAMINATION  
SITE  
EPA ID: ALD980728703**

**PERDIDO, BALDWIN COUNTY, ALABAMA**

**SECOND FIVE-YEAR REVIEW REPORT  
FOR  
OU-1, GROUNDWATER OPERABLE UNIT**

**Prepared By:  
Mobile District  
U.S. Army Corps of Engineers  
P.O. Box 2288  
Mobile, Alabama 36609**

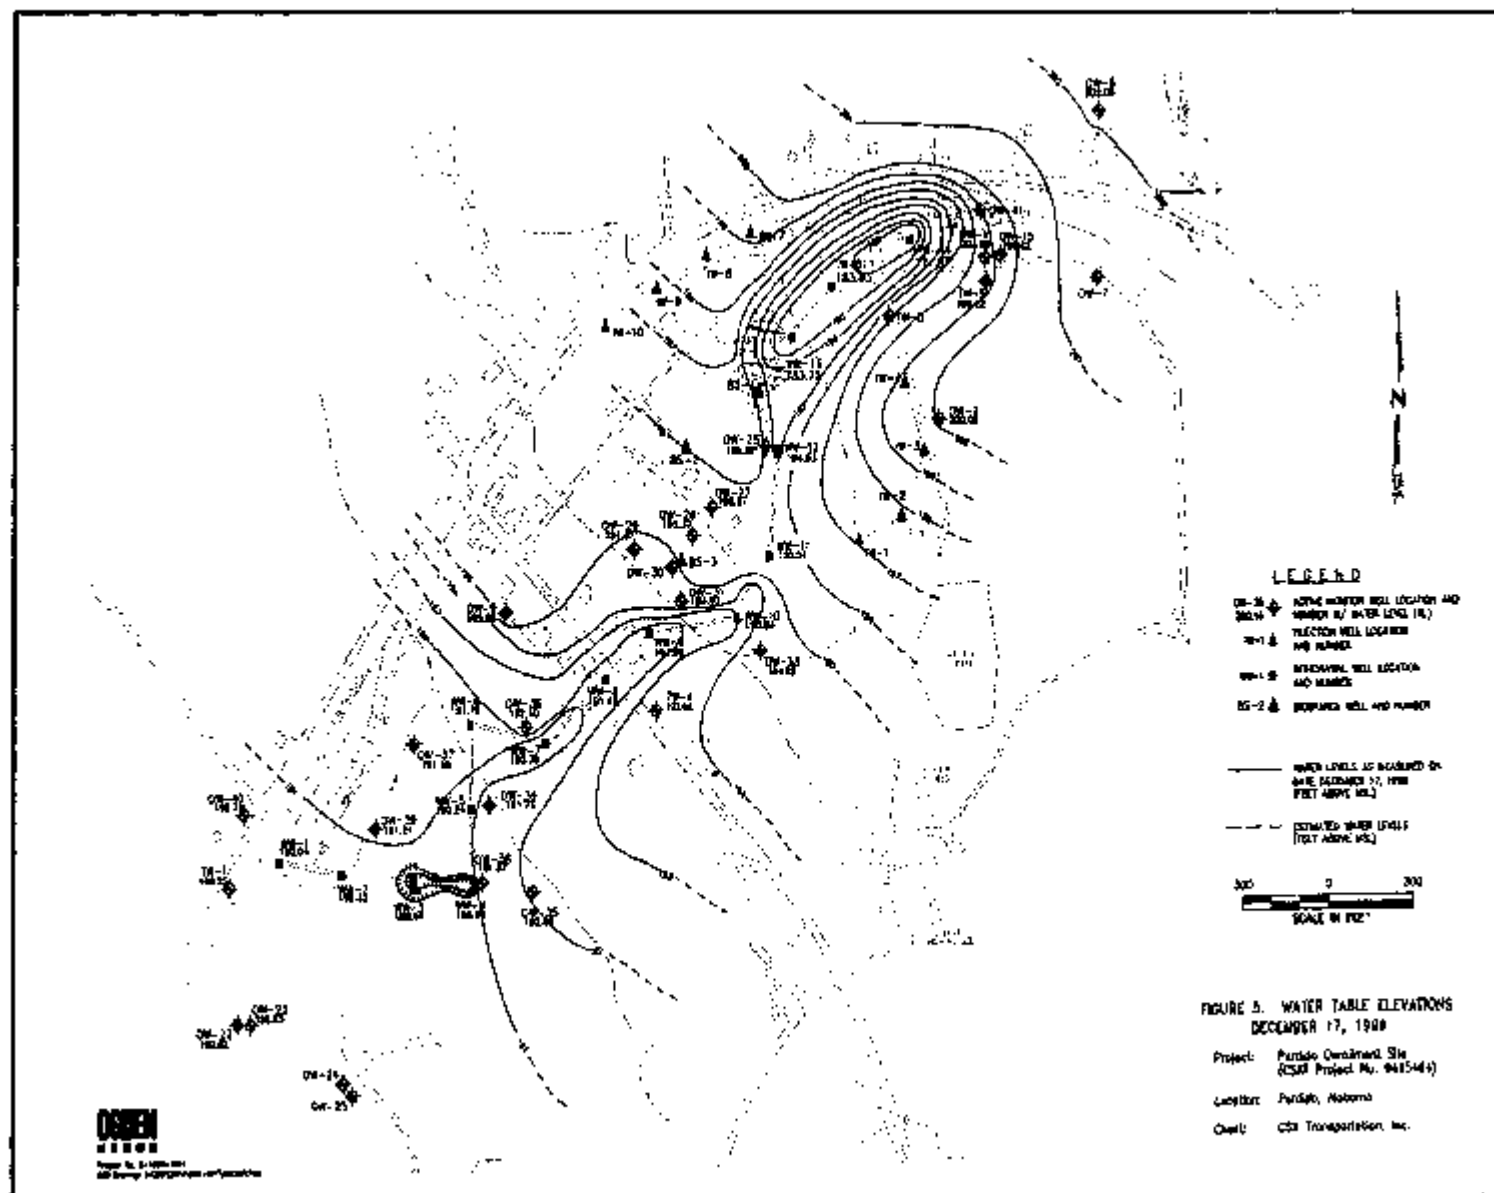
# GROUND WATER ELEVATIONS DECEMBER 1999

Figure 4, Benzene Isopleth Map from the December 1999 Quarterly Report, has closed contours indicating capture of the benzene plume. Figure 5, Water Table Elevations, from the December 1999 Quarterly Report does not indicate the closure shown on the Isopleth Map. After examining the data used to construct the Water Table Map, it appears that the contours can be closed on several of the open intervals, so that the groundwater contour map more closely resembles the benzene isopleth map.

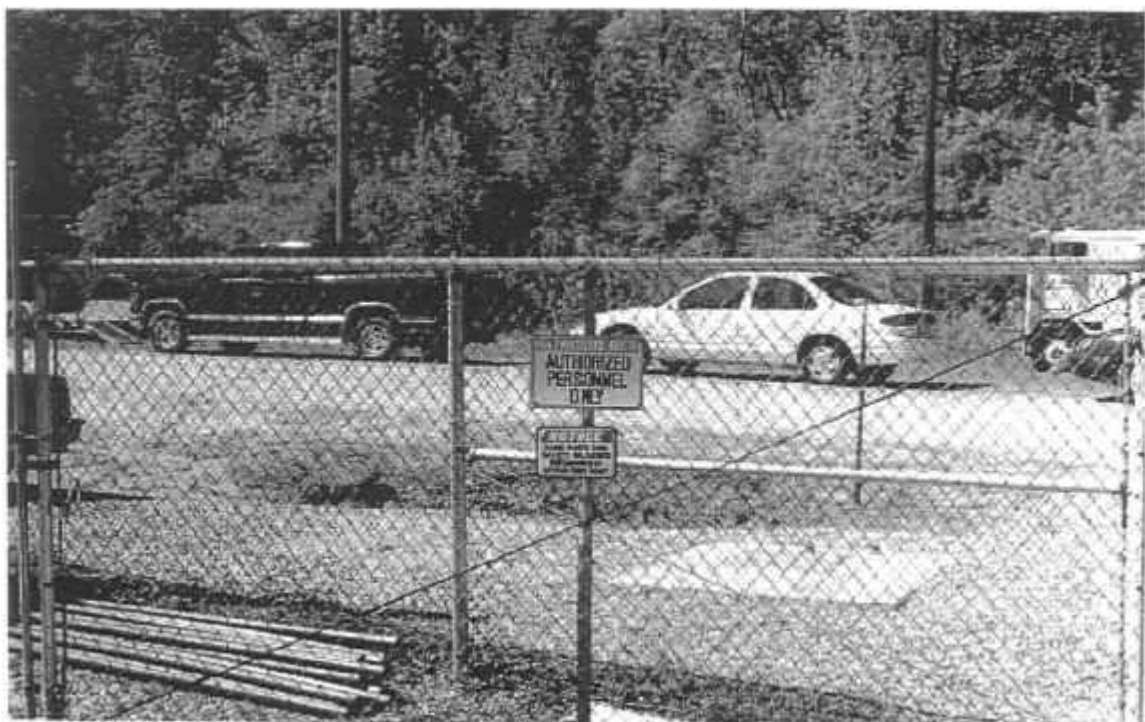
SAFETY AND SECURITY SIGNS ON FENCE GATE

1. Fencing damaged ☐ Location shown on map ☒ Gates secured ☐ N/A  
Remarks: Fence in good repair.

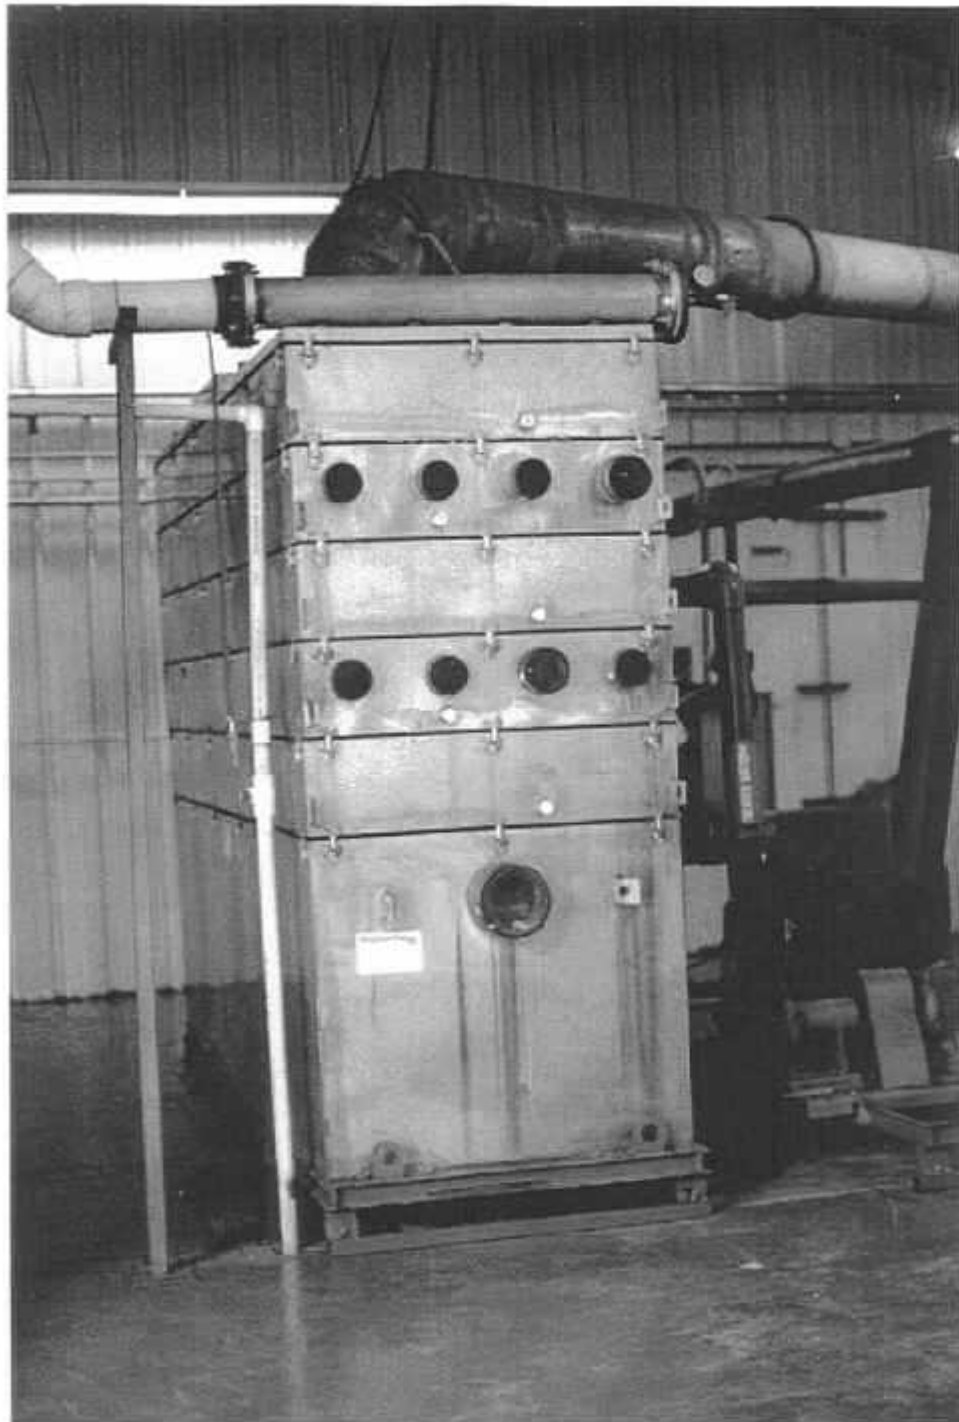
SHALLOW TRAY AIR STRIPPER

The November 1999 sample of the effluent water was 20 ppb, which was well above the regulatory limit of 5 ppb, and was attributed to iron buildup in the air stripper. Iron and sediment fouling is an on going problem and the causes of the fouling are being addressed by Ogden Environmental. According to the December 1999 Quarterly Report, the cleaning schedule for the New England stripper has been significantly modified to reduce the potential for benzene exceedances (>5 ppb) in the effluent due to the continued build up of iron and/or sediment in the stripper. The stripper will be inspected and cleaned every two weeks using an internal cleaning wand. The stripper will be dismantled, inspected and cleaned quarterly.

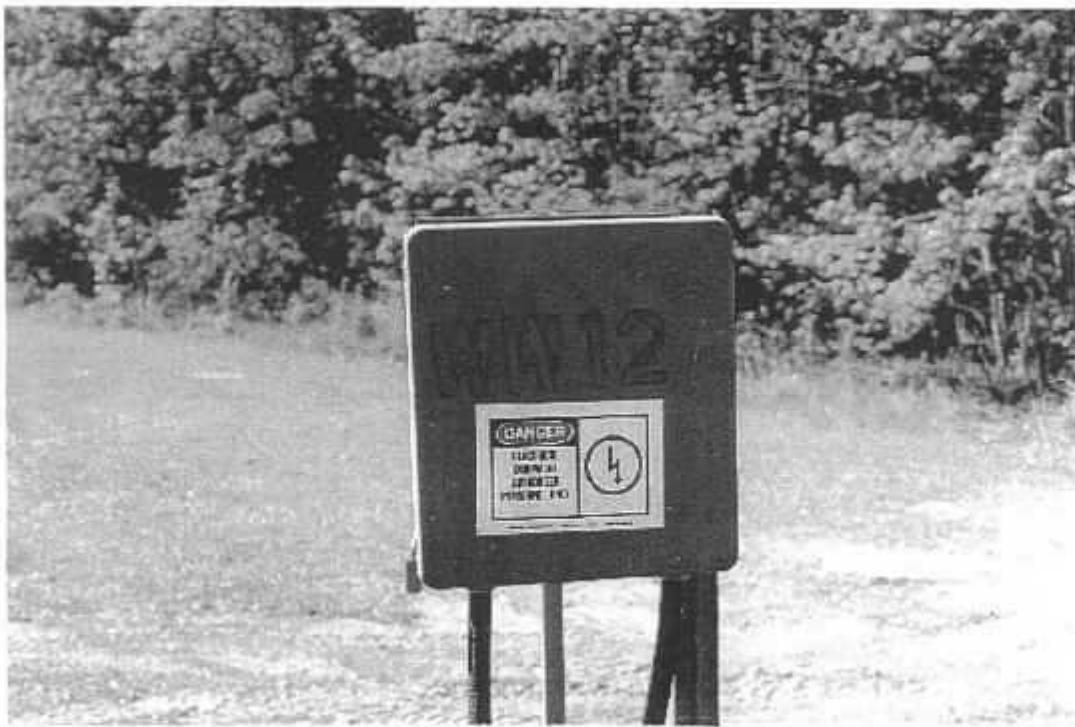
CONTROL BOX FOR WELL WW-12

Extraction well WW-12 was opened for inspection. The well was operating and was in good repair. The wells are now equipped with Grundfos submersible pumps and controllers. The pumps have no-load sensors so that if the well is pumped down to the pump intake, the pump will shut off instead of running until it burns up. Some of the pumps are capable of pumping more water than they are pumping at this time. The pump discharges are throttled back and wells are pumping against a discharge pressures of 10-100 psi. After replacing the cover on well WW-12 the team looked at the extraction wells down to Highway 47.

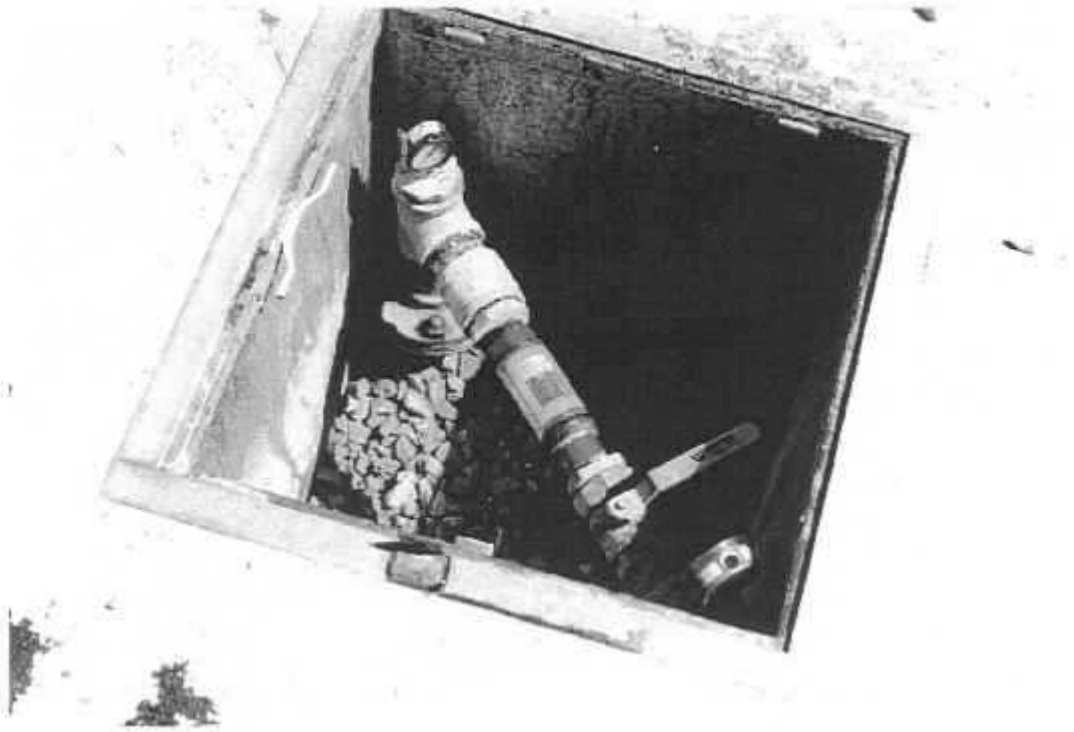
BIOSPARGE WELLS BS-3

The biosparging wells are relatively new and appeared to be in very good condition and functioning as design.

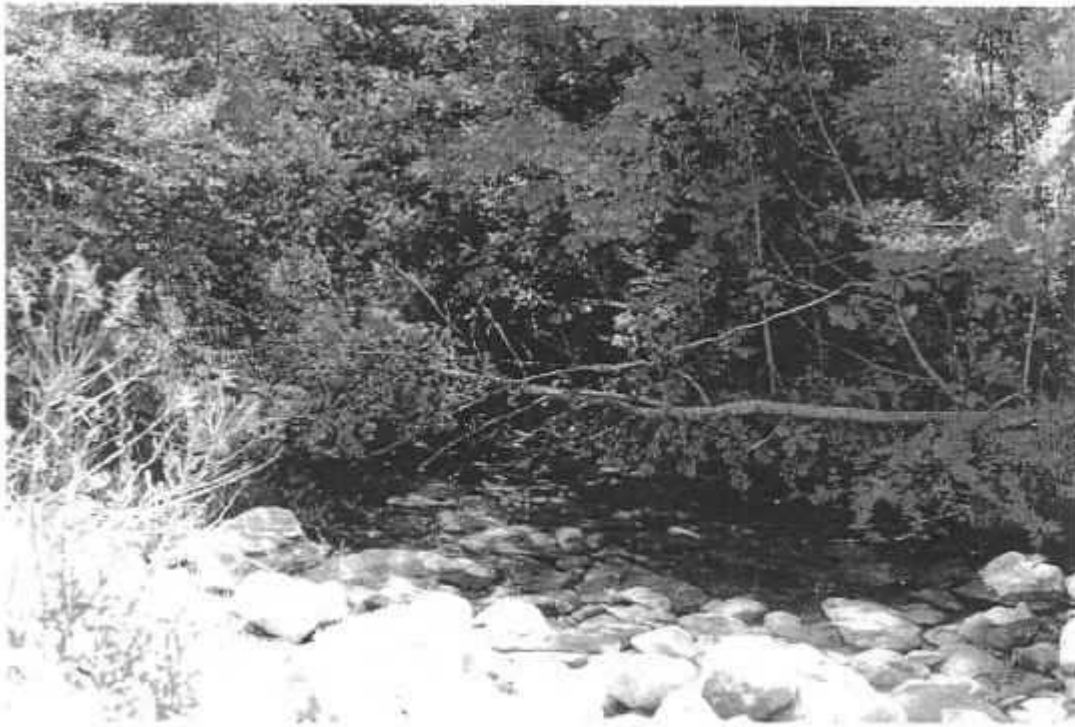
EFFLUENT DISCHARGE TO SURFACE WATER

The team then went by the derailment site and inspected the surface water discharge. The discharge is located in Perdido Creek on the south side of Baldwin County Highway 61. The culverts under the road have recently been replaced and the roadside and creek banks riprapped. The discharge is inconspicuous and appeared to be operating well within the 100 gpm discharge limit.
